EA-6B HVOF-Coated Landing Gear: Post-Deployment Inspection Results

Tai Ngin
Materials Engineer
NAVAIR FRCSE, 43410

13. SUPPLEMENTARY NOTES ASETSDefense 2009: Sustainable Surface Engineering for Aerospace and Defense Workshop, August 31 - September 3, 2009, Westminster, CO. Sponsored by SERDP/ESTCP.

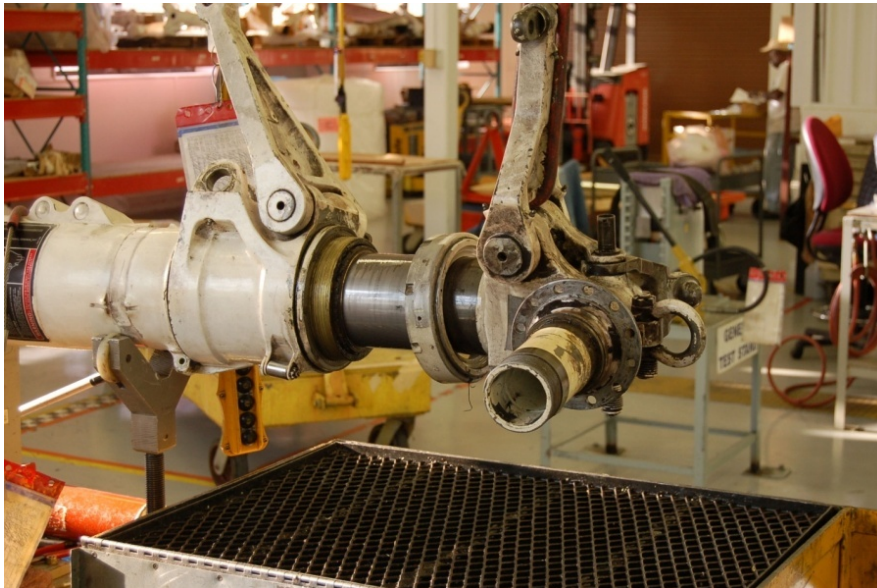
- Strut Disassembly
 - Performed due to leak in lower seal

HVOF coated axle and piston
during tear down

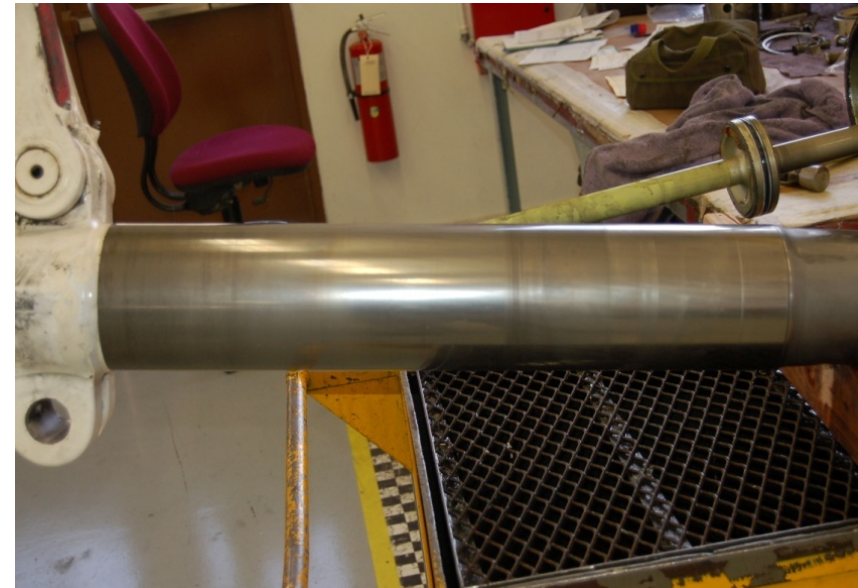
HVOF coated piston during
disassembly

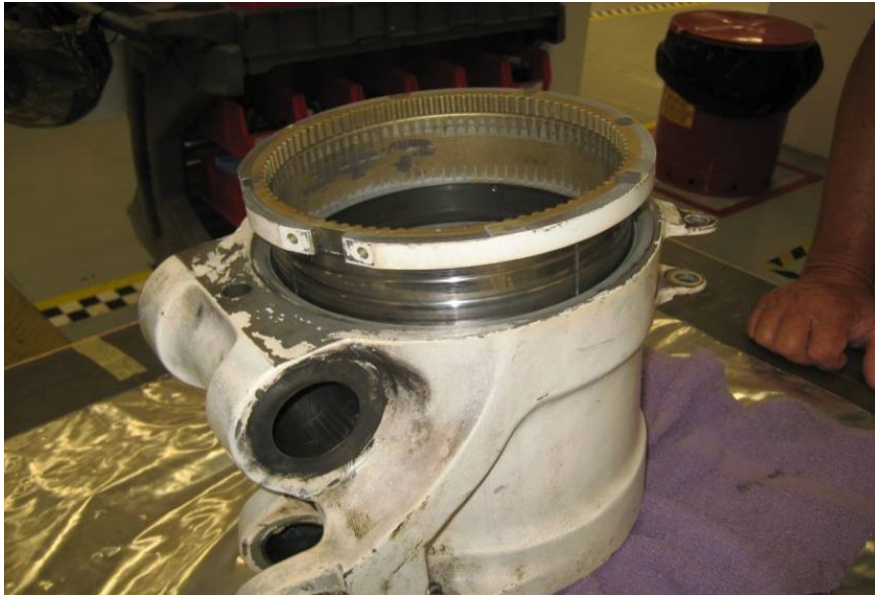
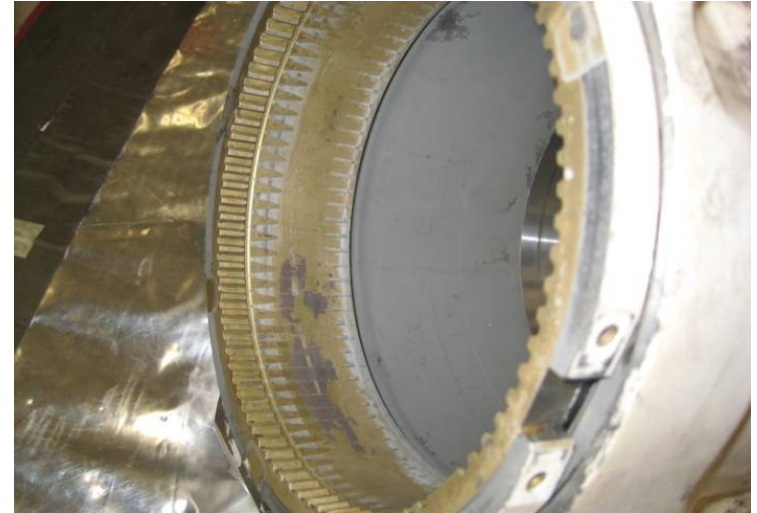
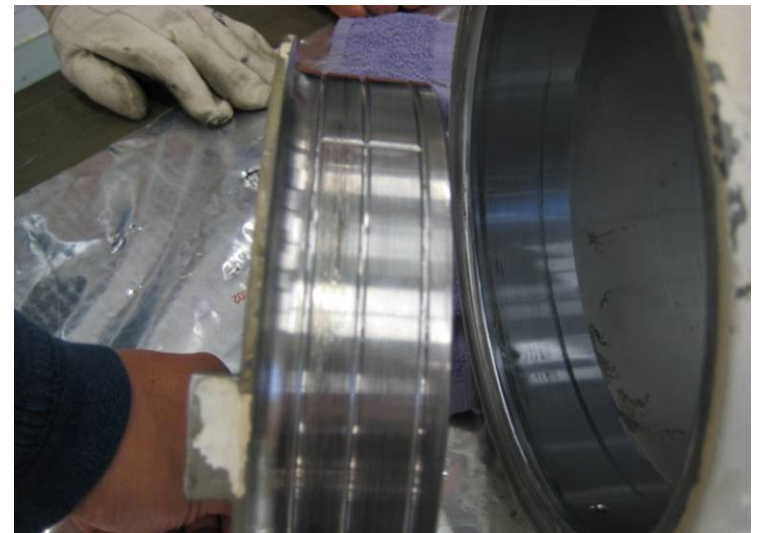
- Collar Assembly
 - No indications of wear or other damage

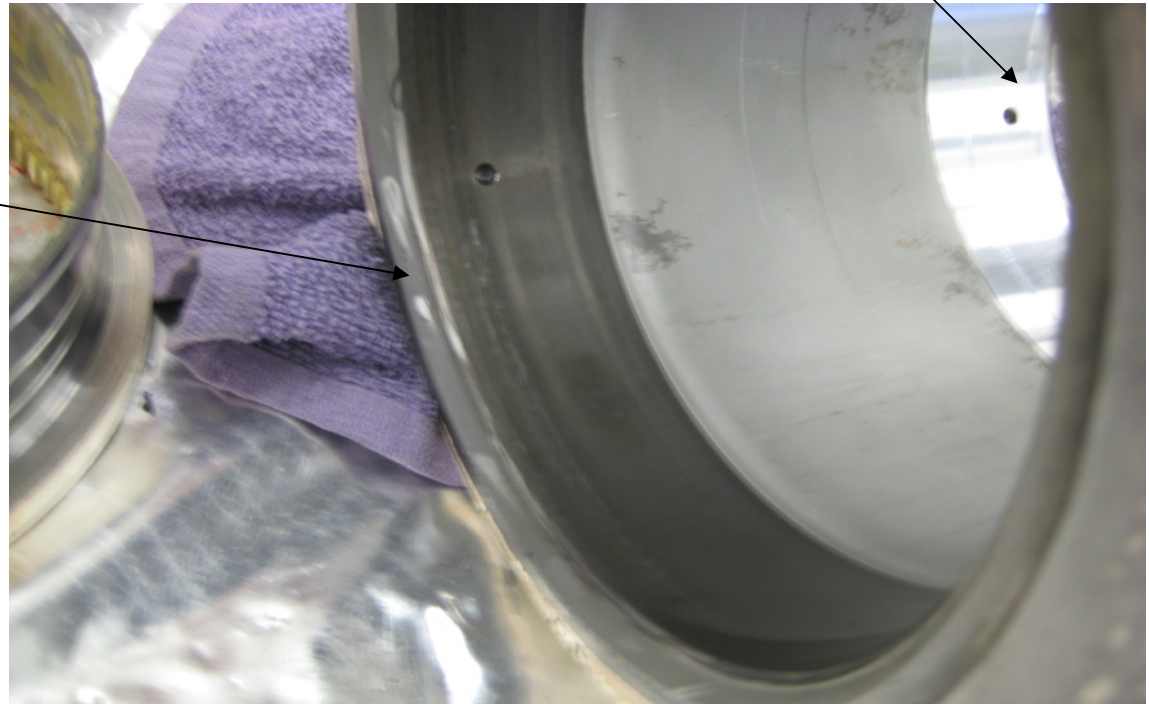
HVOF coated area

Surface finish $R_a = 7 \mu\text{in}$;
 $R_a = 10\text{-}11 \mu\text{in}$ at outer most
edge shown

Chrome plated area

Surface finish $R_a = 6\text{-}7 \mu\text{in}$

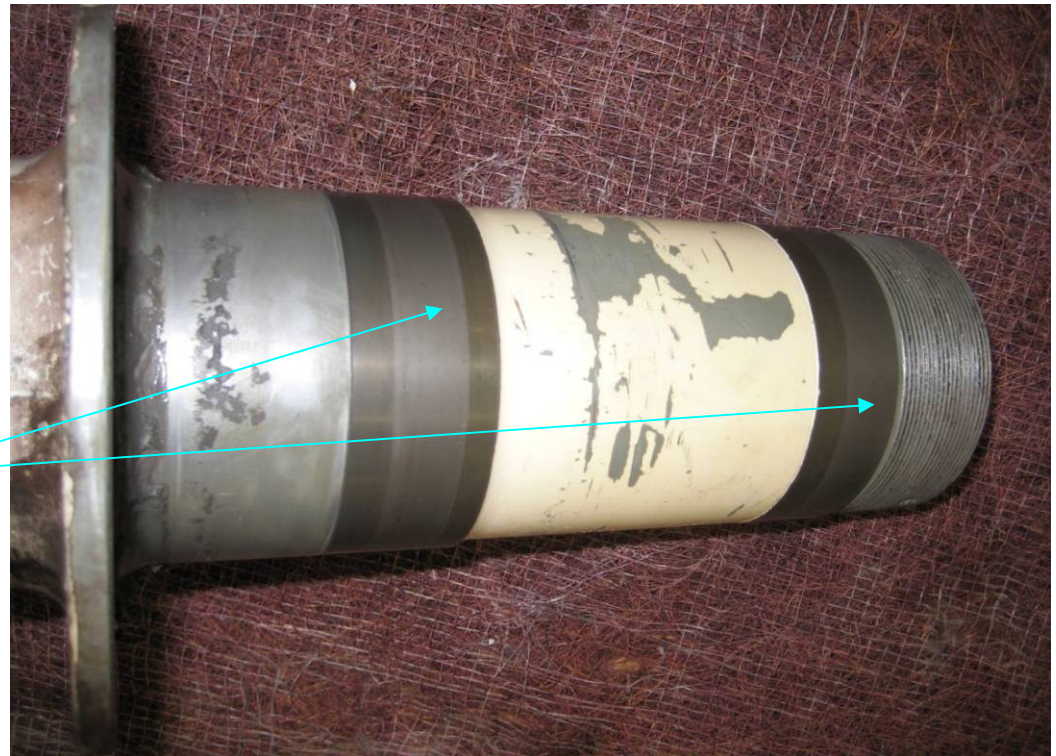
HVOF on Axle Journals, edges in good condition, coating appeared to be in very good condition

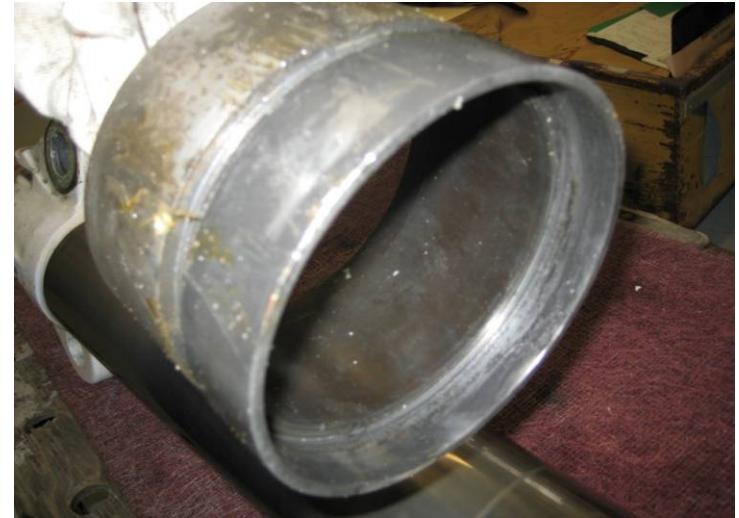
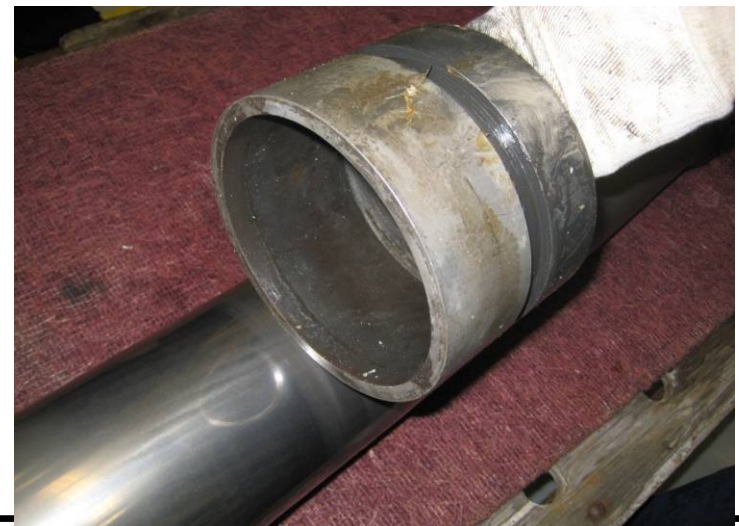
- Collar Bushing
 - The original item was discarded after disassembly
 - Operators reported part corroded
 - Corrosion typical for this part in service.

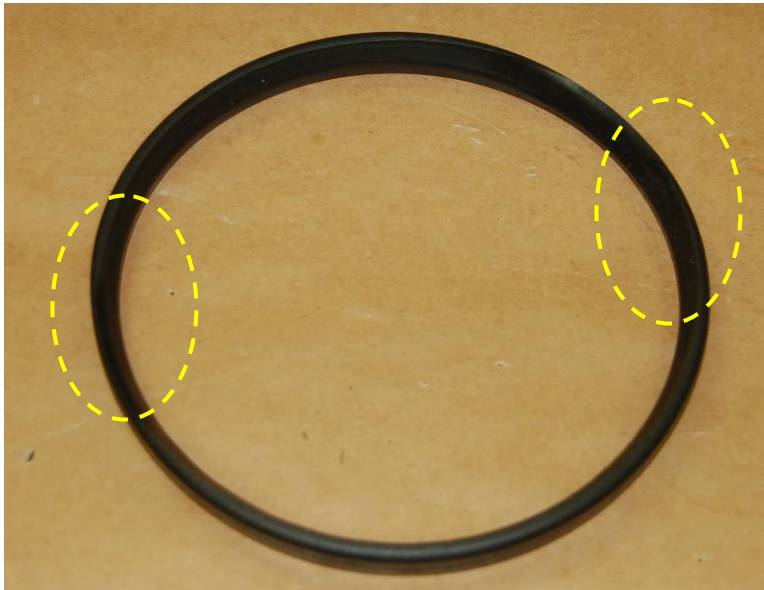
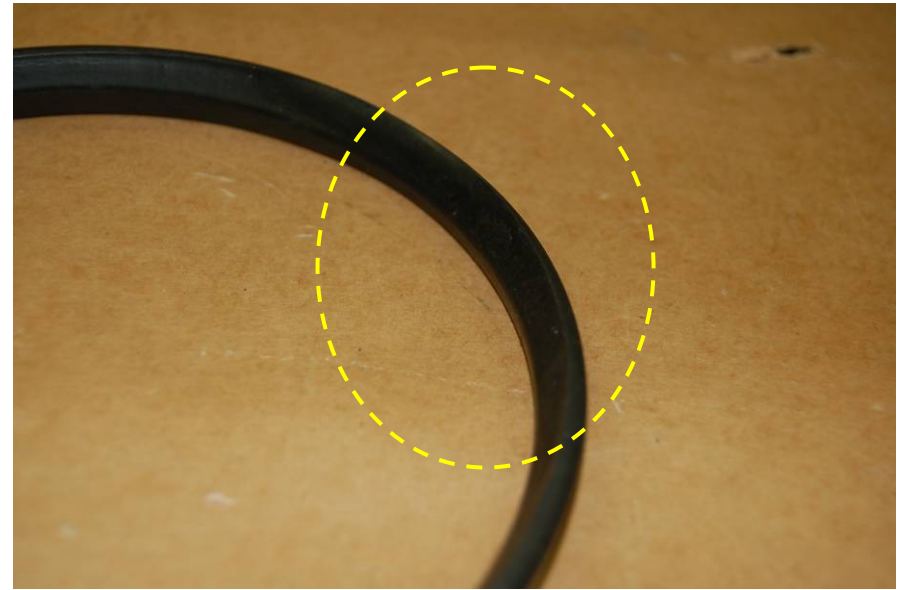
- Seal wear (“flat spots”) at 0° and 180°
- Possible service in Middle East: sand entrapment / intrusion issues
- Failure analysis will be performed by Trelleborg Sealing Solutions (POC: John Nash)

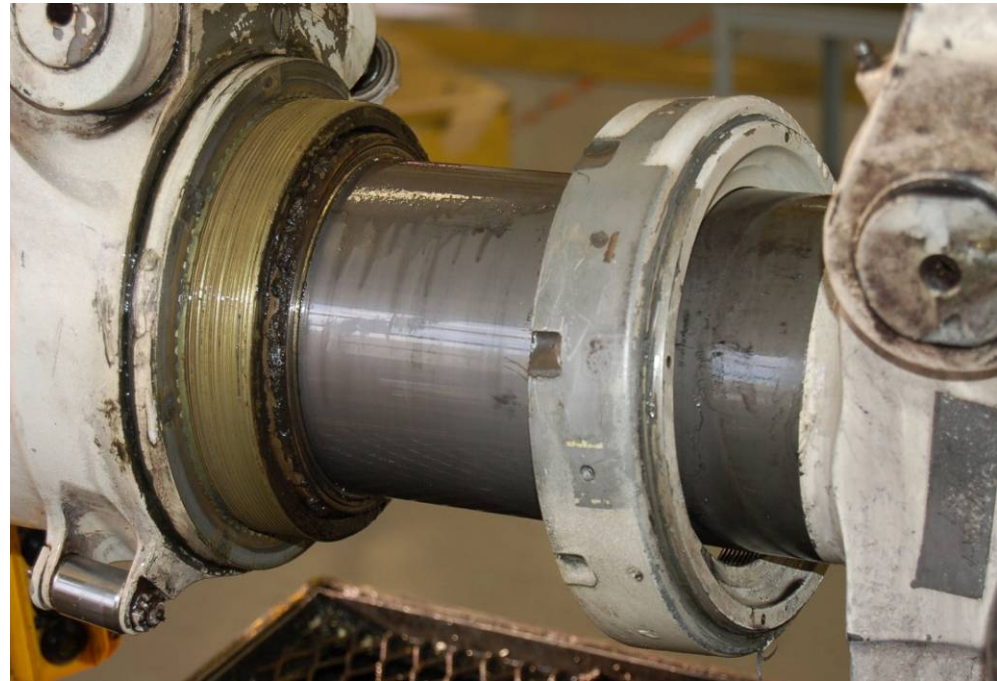
Disassembly of collar and seal retainer in location of leak

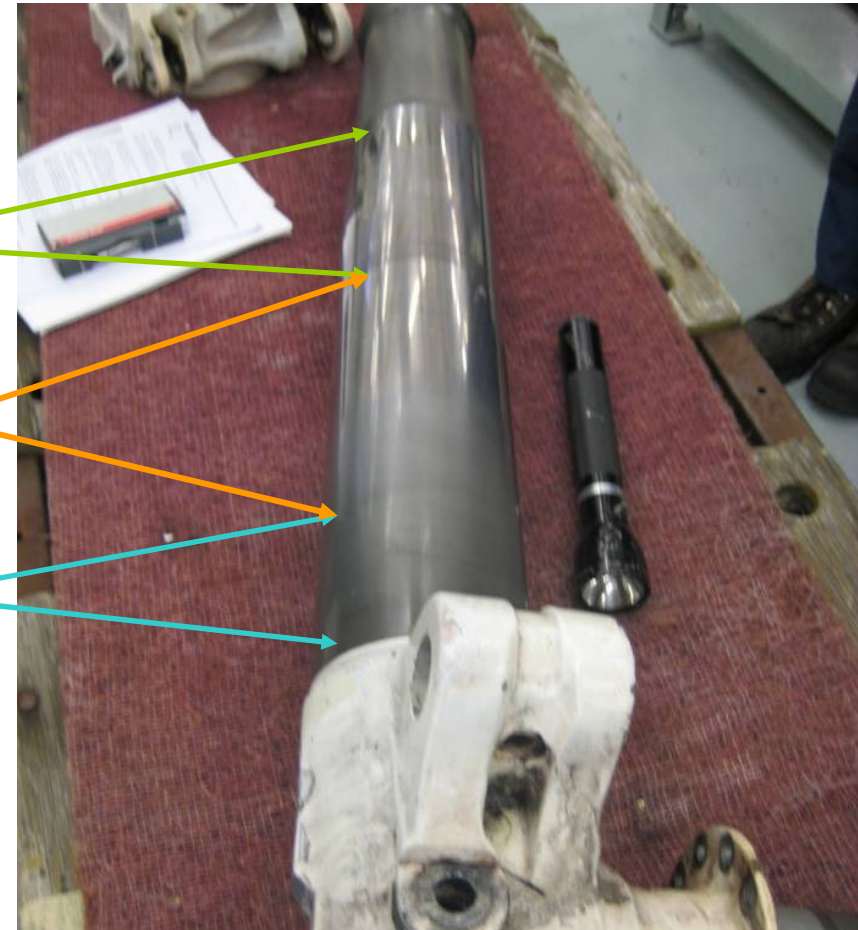
Surface finish measured Ra 3-4 μin

Surface finish Ra 8-10 μin in center section

Surface finish measured Ra 11-18 μin in area 2" to 8" from base

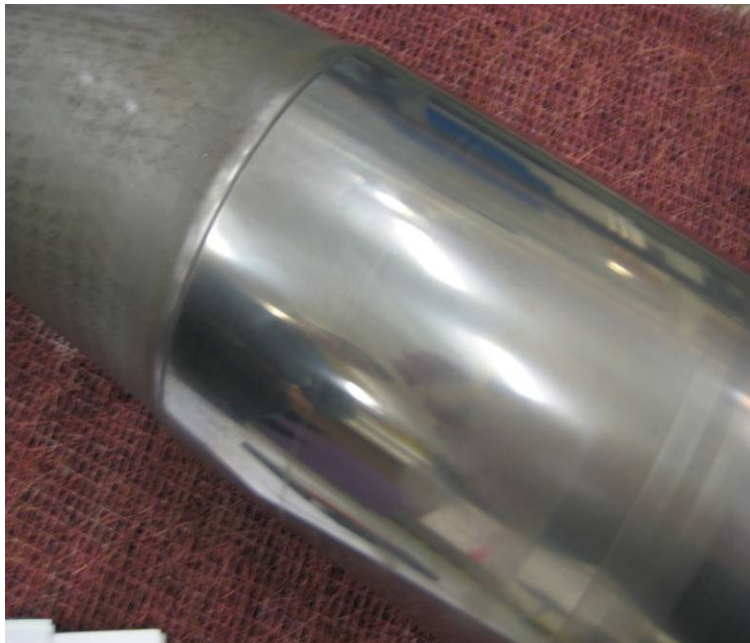
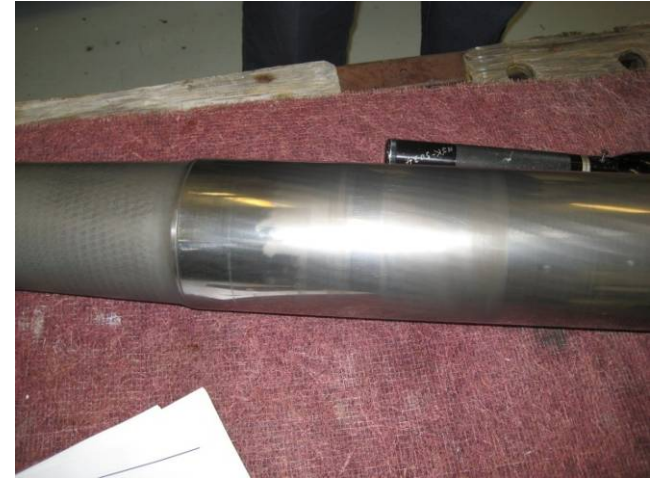
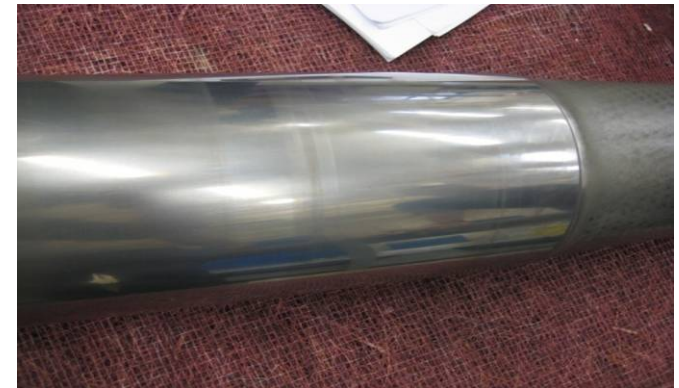
Finish Roughness (Ra) = 2-3 μin

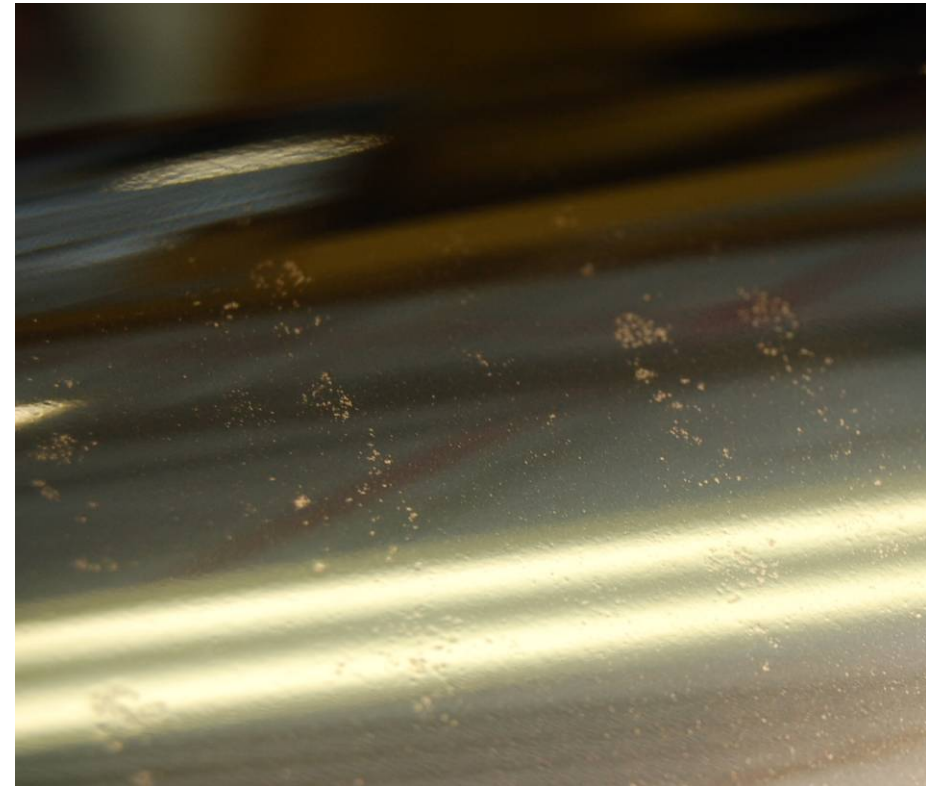
- Corrosion issues
 - FPI initially found no indications
 - After superfinishing, pits found in the coating
 - Co binder highly susceptible to salt corrosion

- First/Best option: Keep Current Coating
 - Re-superfinish current pitted HVOF coating
- Goal: Remove pits, establish Ra of 2-4 μin
 - Want coating thickness above minimum tolerance
 - If not, then part is in a state of Functionally Unusable Component Technology

- **Second/Last option: Apply New Coating**
 - Grind pitted coating to parent metal
 - Recoat the part to return to service
 - Apply chrome coating -OR-
 - Reapply HVOF coating
- **Complications**
 - Future HVOF coating choice
 - DIAMALLOY 2005: 83WC-17Co
 - AMDRY 5843 (AMS 2447-9): 86WC-10Co-4Cr
 - **FUNDING!?!?**
 - *“Hubba, hubba, hubba, money, money, money...who do you love?”*
